INCIDENT INVESTIGATION REPORT

Crude Oil Discharge to Lake Michigan

Whiting Business Unit

Incident Date: March 24, 2014
Investigation Start Date: March 26, 2014
MI/HiPo Notification Date: March 25, 2014
Report Issued: August 20, 2014
Traction Report: 4674318

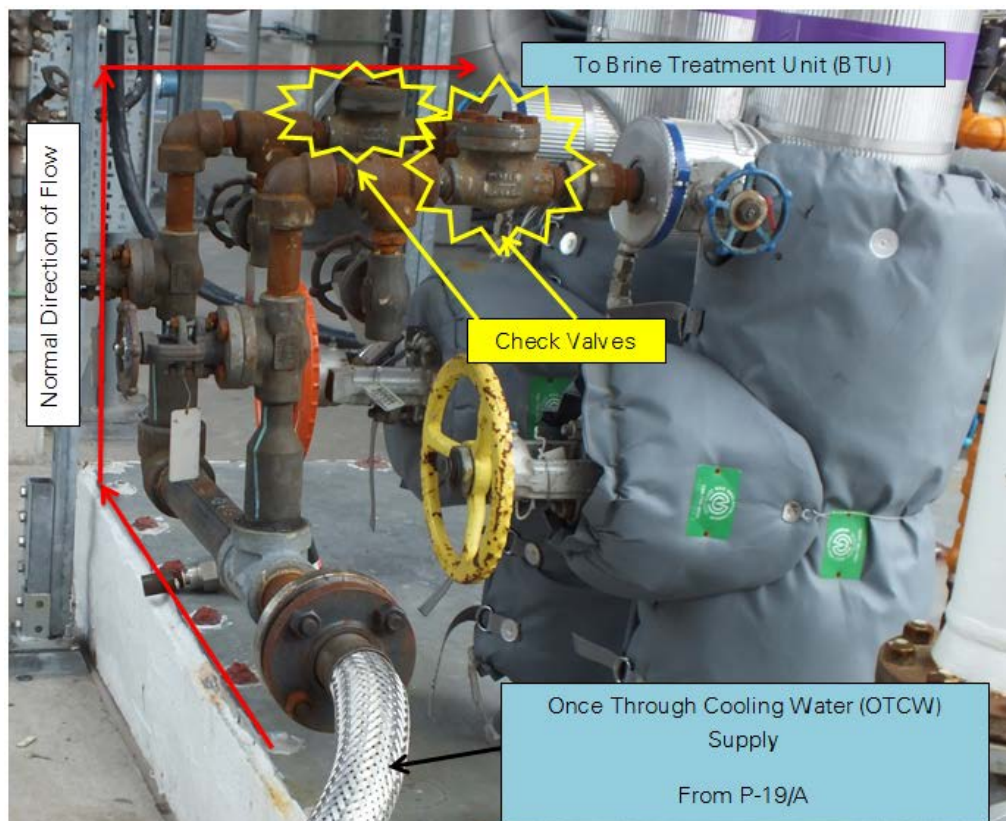
Figure 4 Connection of the temporary quench line 1-inch manifold (including two 1-inch check valves) to the brine system near D-14 junction box.

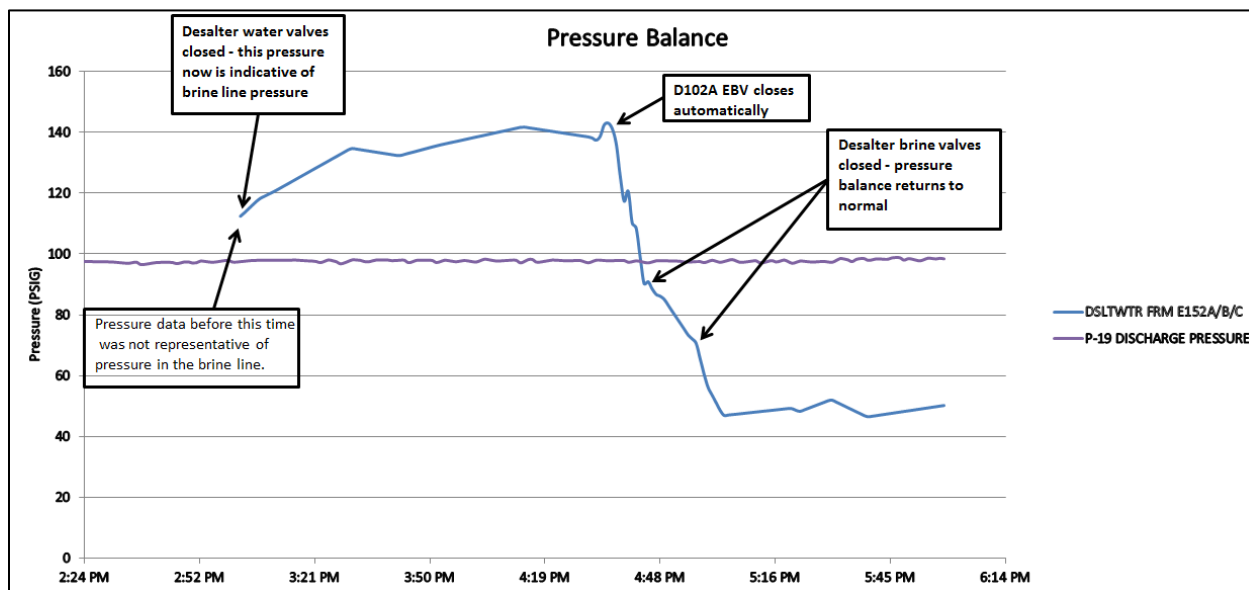
Figure 5: Pressure balance between the brine line and OTCW system.

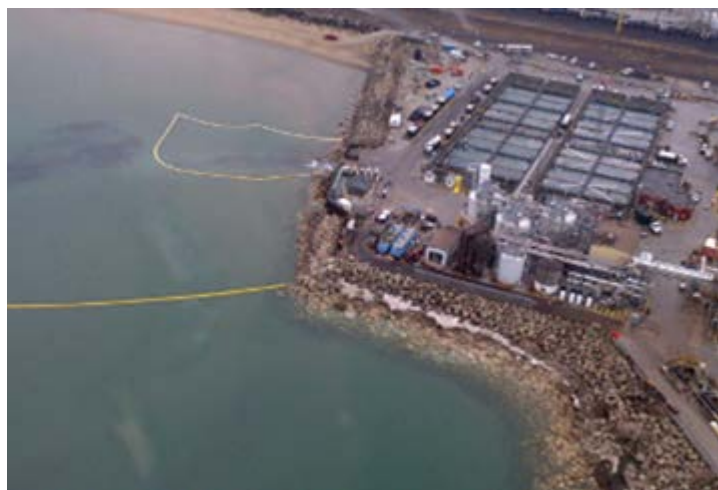
Figure 6: Aerial photo showing deployment of boom at the No. 6 Separator outfall.

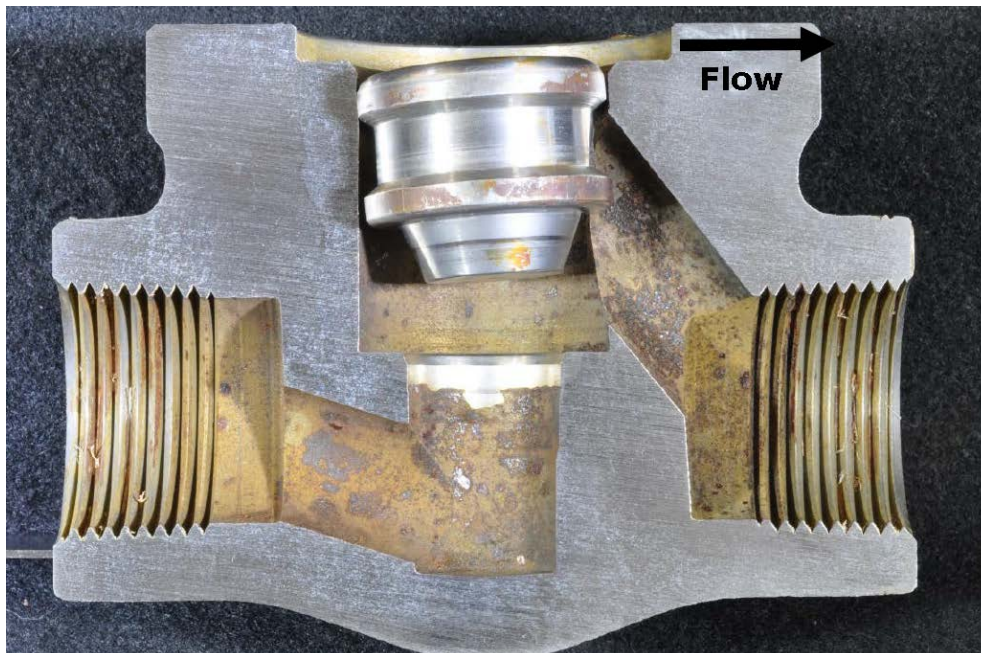
Det Norske Veritas (DNV) conducted mechanical and metallurgical testing of the two one-inch check valves and determined that one or both of the valves failed due to grooves that developed in the valve bodies while in service. Given the operating conditions and materials of construction, the two most likely primary corrosion mechanisms are galvanic corrosion and fretting corrosion, which may have been accelerated by the flow conditions within the valve. These mechanisms are described below:

- Galvanic corrosion may have occurred where the carbon steel valve body was in contact with the 410 stainless steel piston in the presence of an electrolyte (lake water).
- Fretting corrosion likely occurred due to small vibrations of the piston caused by turbulent flow which helped break apart and facilitate the removal of corrosion products and allows continuous

contact of the 410 stainless steel piston and the carbon steel valve body. The turbulent flow was caused by elevated flow velocity through the check valve which was approximately 25 feet per second (fps), compared to a recommended maximum velocity of 10 fps⁴.

The velocity of water through the valve may have contributed to the removal of corrosion products, accelerating the galvanic and/or fretting corrosion. BP valve experts and metallurgists had not experienced similar failures of piston check valves due to a combination of these corrosion mechanisms in similar service.

Mechanical testing completed by DNV did not replicate the failure that occurred during the incident likely because the test flow rates could not replicate the high flow rates while the valves were in service. Nonetheless, DNV concluded that the grooves in the valve body prevented the piston from seating during backflow conditions allowing the crude and brine to backflow into the OTCW System (see Figure 7).

Figure 7: Grooves (not visible in this photo) in the valve body allowed the piston to rest in a tilted position preventing it from reseating during back flow conditions. The direction of normal flow is shown.

- Complete additional testing to determine the rate of galvanic corrosion between carbon steel and stainless steel in lake water. Based on the results of this testing, update Whiting technical practices for selecting valves and clarify/reinforce velocity limits for piping and components. Share this learning with BP and the industry.

- Where the combined corrosion mechanisms could occur in similar check valves in similar service, verify the design and take necessary corrective action.
